BOG BROOK DAM

NH 00189

PHASE I INSPECTION REPORT
NATIONAL DAM INSPECTION PROGRAM

NOVEMBER 1978

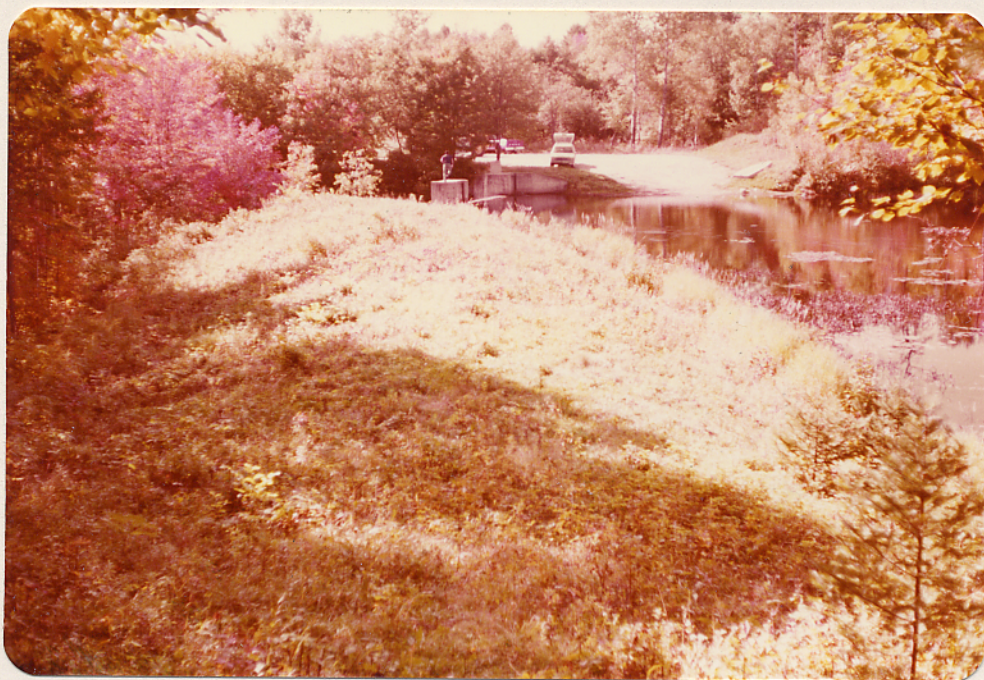
Overview of dam from left abutment

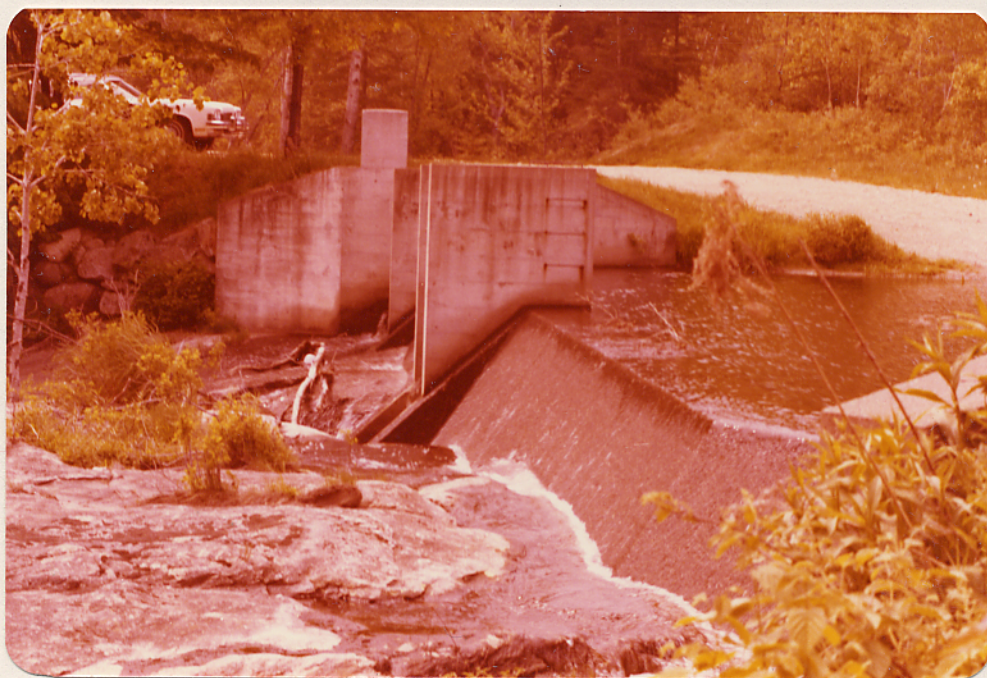
Overview of dam from left spillway
endwall

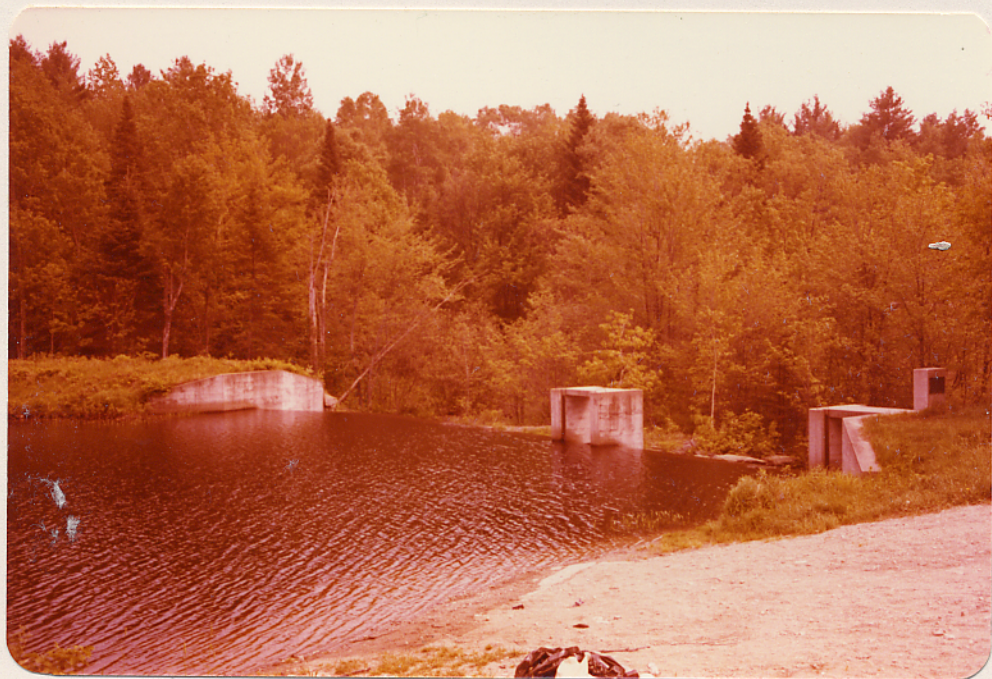
Overview of dam from upstream right
side

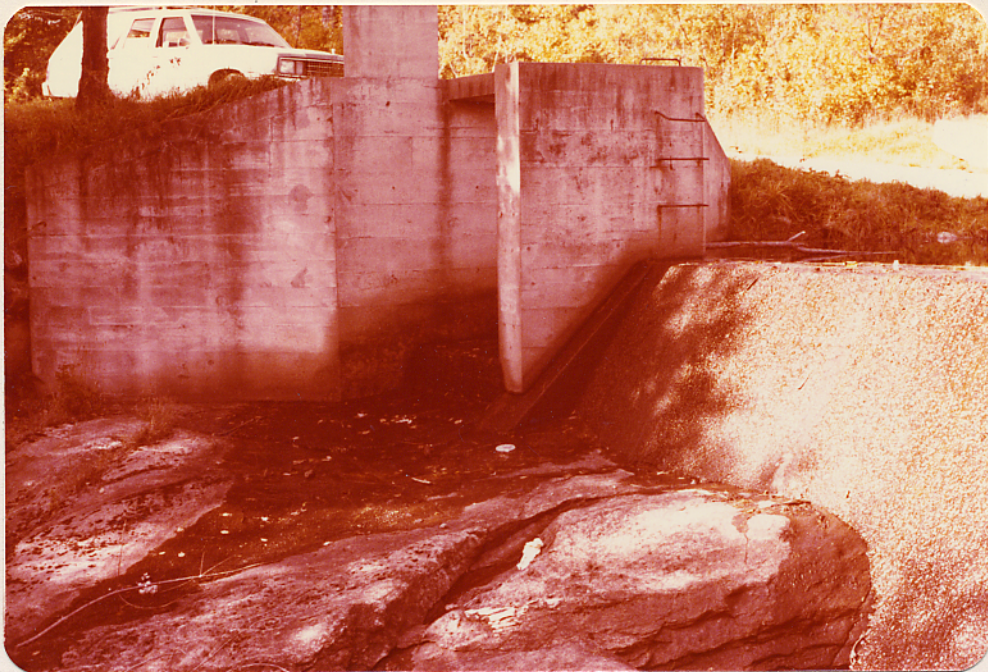
1. View of right sluiceway showing bedrock foundation under concrete portions of dam

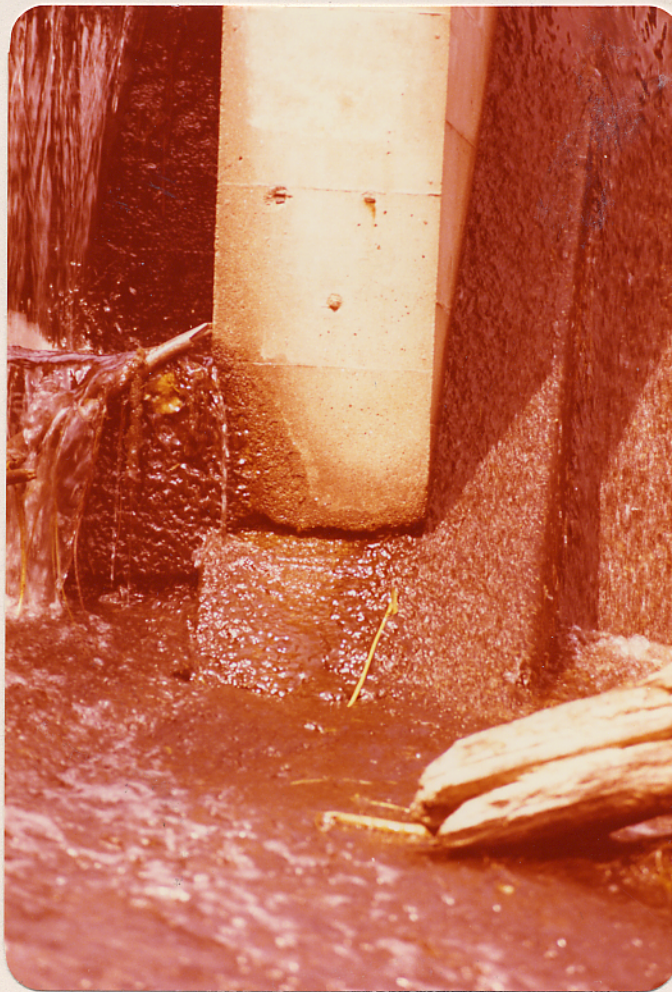
Both sluiceways show evidence of erosion along the construction joints between their side-walls and the buttress supports on the spillway sides of these structures. Efflorescence and fine random cracking is evident along the same joint on the inside face of both sluiceways. Minor erosion was observed on the concrete sill in the sluiceway located at the right spillway endwall. The stoplogs in place in the sluiceways are in good condition.

2. Detail of Photo 1 showing erosion of construction joint between sluiceway sidewall and spillway buttress support

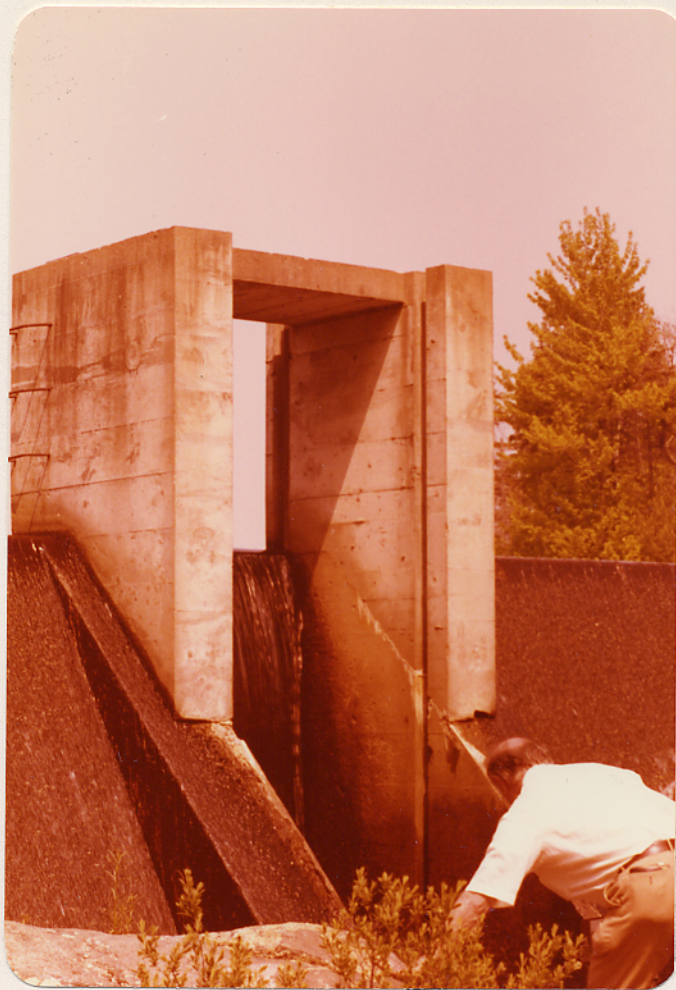
3. View of center sluiceway showing erosion between sluiceway sidewalls and spillway buttress supports

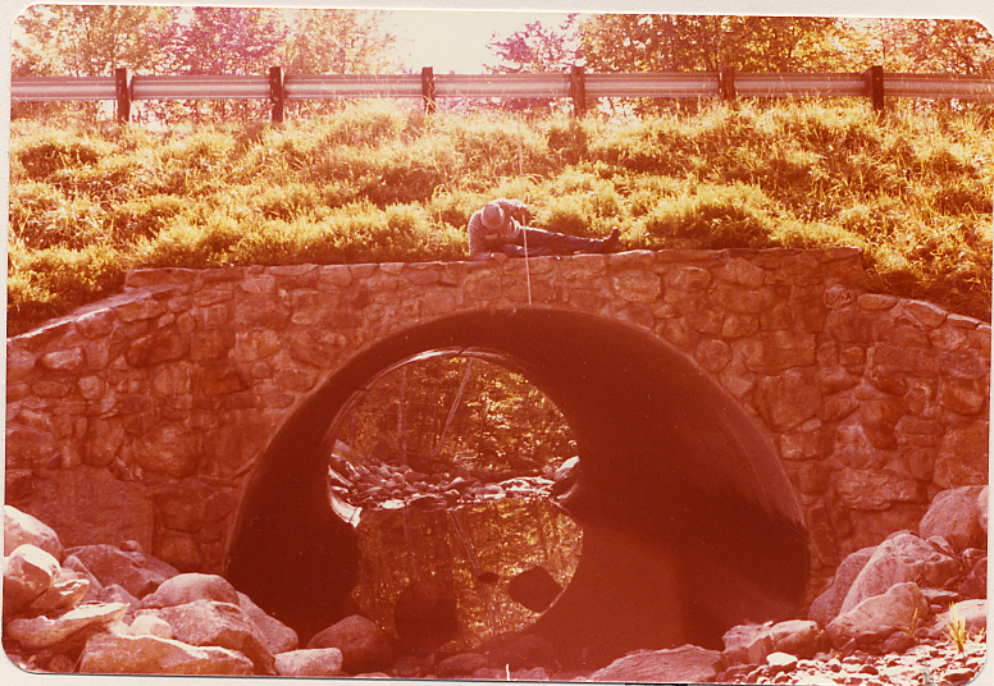
4. View from channel between dam and road showing bridge culvert
